DELAWARE RIVER BASIN
BUCKSHUTEM CREEK
CUMBERLAND COUNTY
NEW JERSEY

BEAVER DAM
NJ 00077

PHASE 1 INSPECTION REPORT
NATIONAL DAM SAFETY PROGRAM

Name of Dam Beaver Dam Fed ID# NJ 00077 and NJ ID# 503

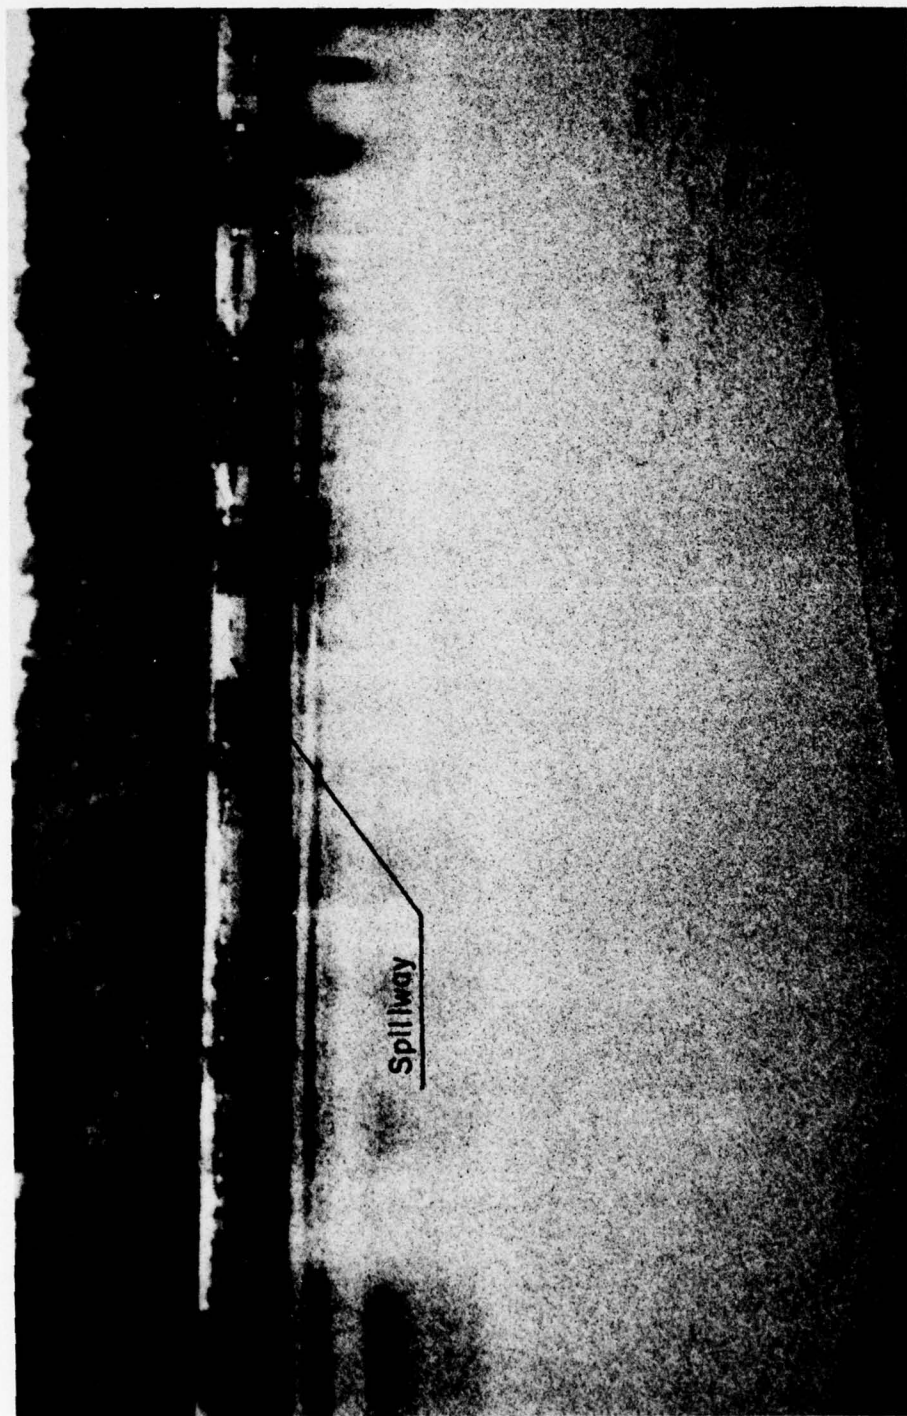
Spillway

OVERVIEW OF BEAVER DAM

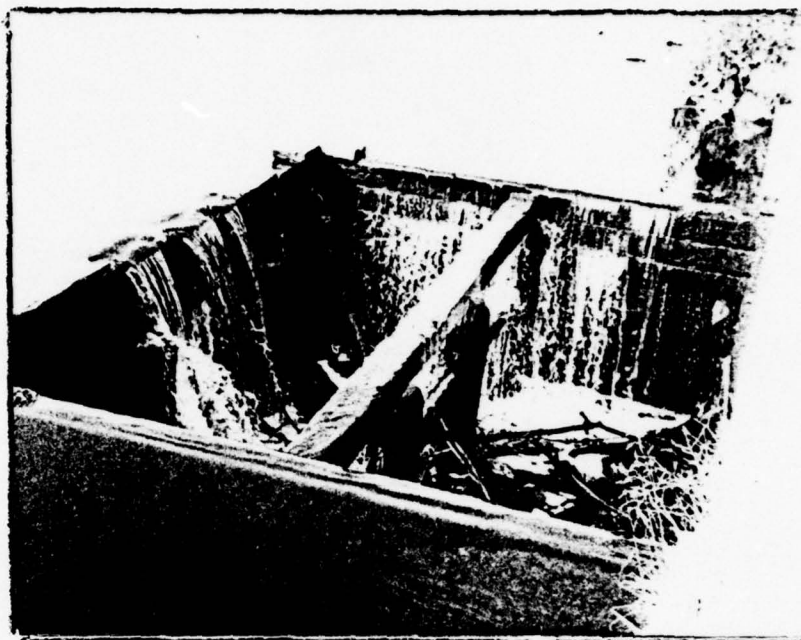
Timber box spillway

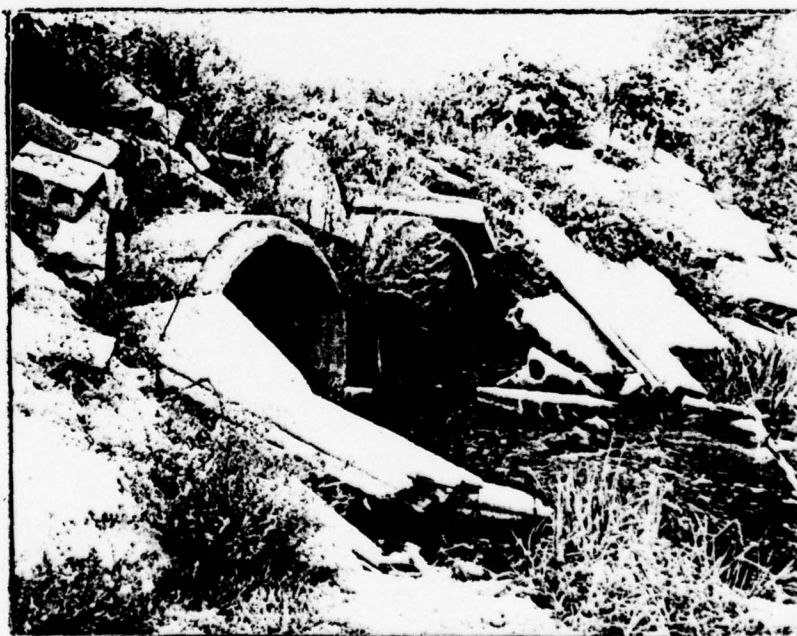
A considerable amount of broken concrete building floor planking has been dumped each side of the 66" RCP pipe outlets. However, it is poorly positioned and its effectiveness as slope protection is thought to be marginal since the planking may be masking eroded pockets or burrows beneath.

Outfall of 2-66" \emptyset R.C.P.

- 1) On the basis of the present conditions and geometry, remedial improvements to the existing spillway is not warranted. The deteriorated upper members of bulkhead and inlet should be replaced and the debris cleaned out of the inlet and pipes.
- 2) The shoulders of the crest should be regraded, levelled and compacted and the trees removed along the upstream crest.
- 3) The trash should be cleared from the backslope near the south abutment and the area regraded and seeded.
- 4) The randomly dumped concrete building plank could be broken up into smaller segments and seated more uniformly into the backslopes. A gravel bedding layer should be placed under the concrete pieces where complete relocation is feasible.

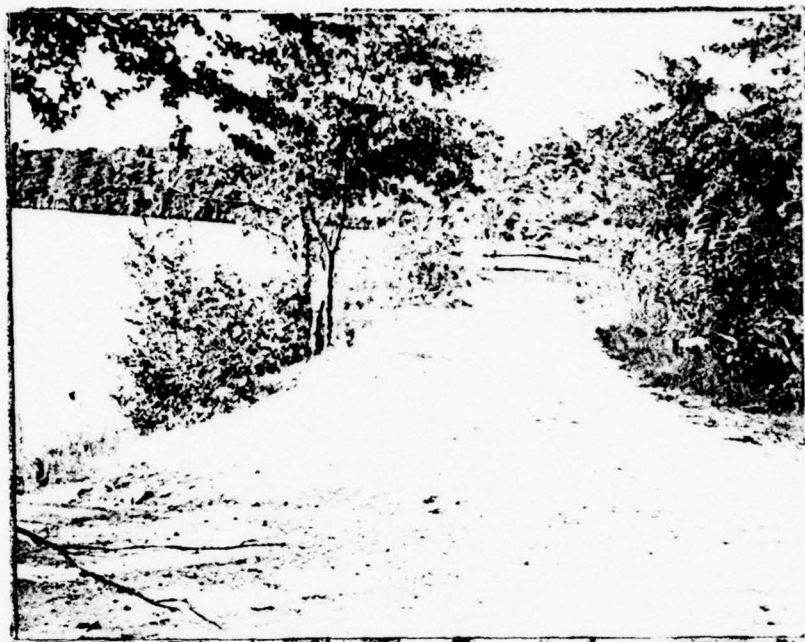
The embankment portions were found to be substantially as designed and in a stable condition although the design crest width and side slopes are extremely ill-defined. The lake level appears to be fairly constant during extensive periods as the banks are well stabilized and show little evidence of sloughing at higher water levels. It appears that after the 1927 breaching the uncontrolled flow was allowed to revert into the natural riverbed of Buchshutem Creek (as evidenced by secondary growth in the upper end of the reservoir). The embankment back-slopes are covered with secondary timber growth and there is quite an extensive amount of trash dumped on the downstream face to the right of the spillway. The dam crest is quite uneven and has sloughed off at the shoulder lines. Certain areas near the right abutment have distinct erosion swales established as have numerous other zones on both the upstream and downstream faces. Much of the crest erosion is caused by minibike rutting, especially at the left abutment where the effective crest width is presently only about 5 feet.

View North along crest

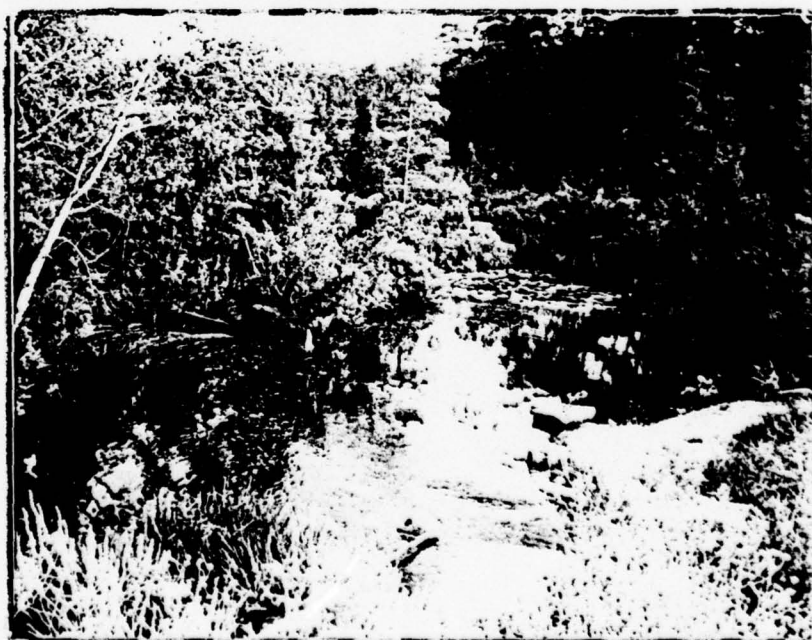
Downstream channel (Laurel Lake)

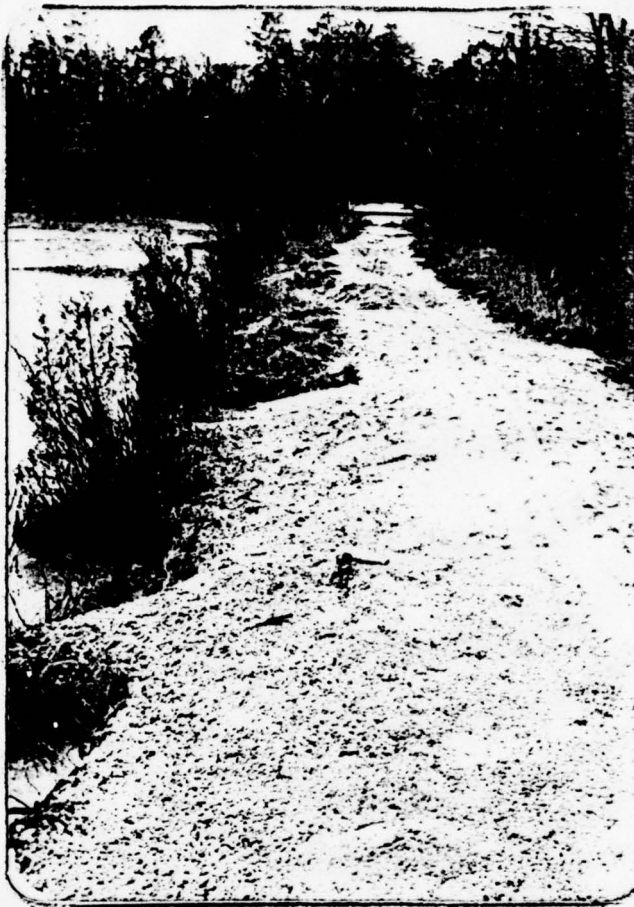
Earth embankment left of spillway

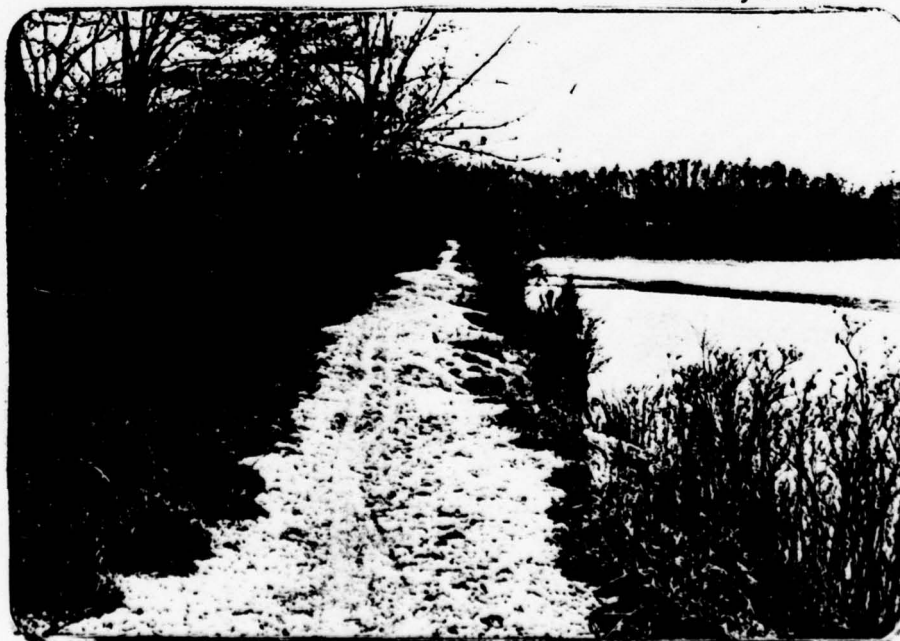
View South from left abutment
